TECHNICAL REPORT GL-90-16

# INVESTIGATIONS OF MAGNETIC FIELD DISTURBANCES AT LITTLE ROCK AIR FORCE BASE COMPASS CALIBRATION HARDSTAND

Dwain K. Butler, Thomas B. Kean

September 1990  
Final Report

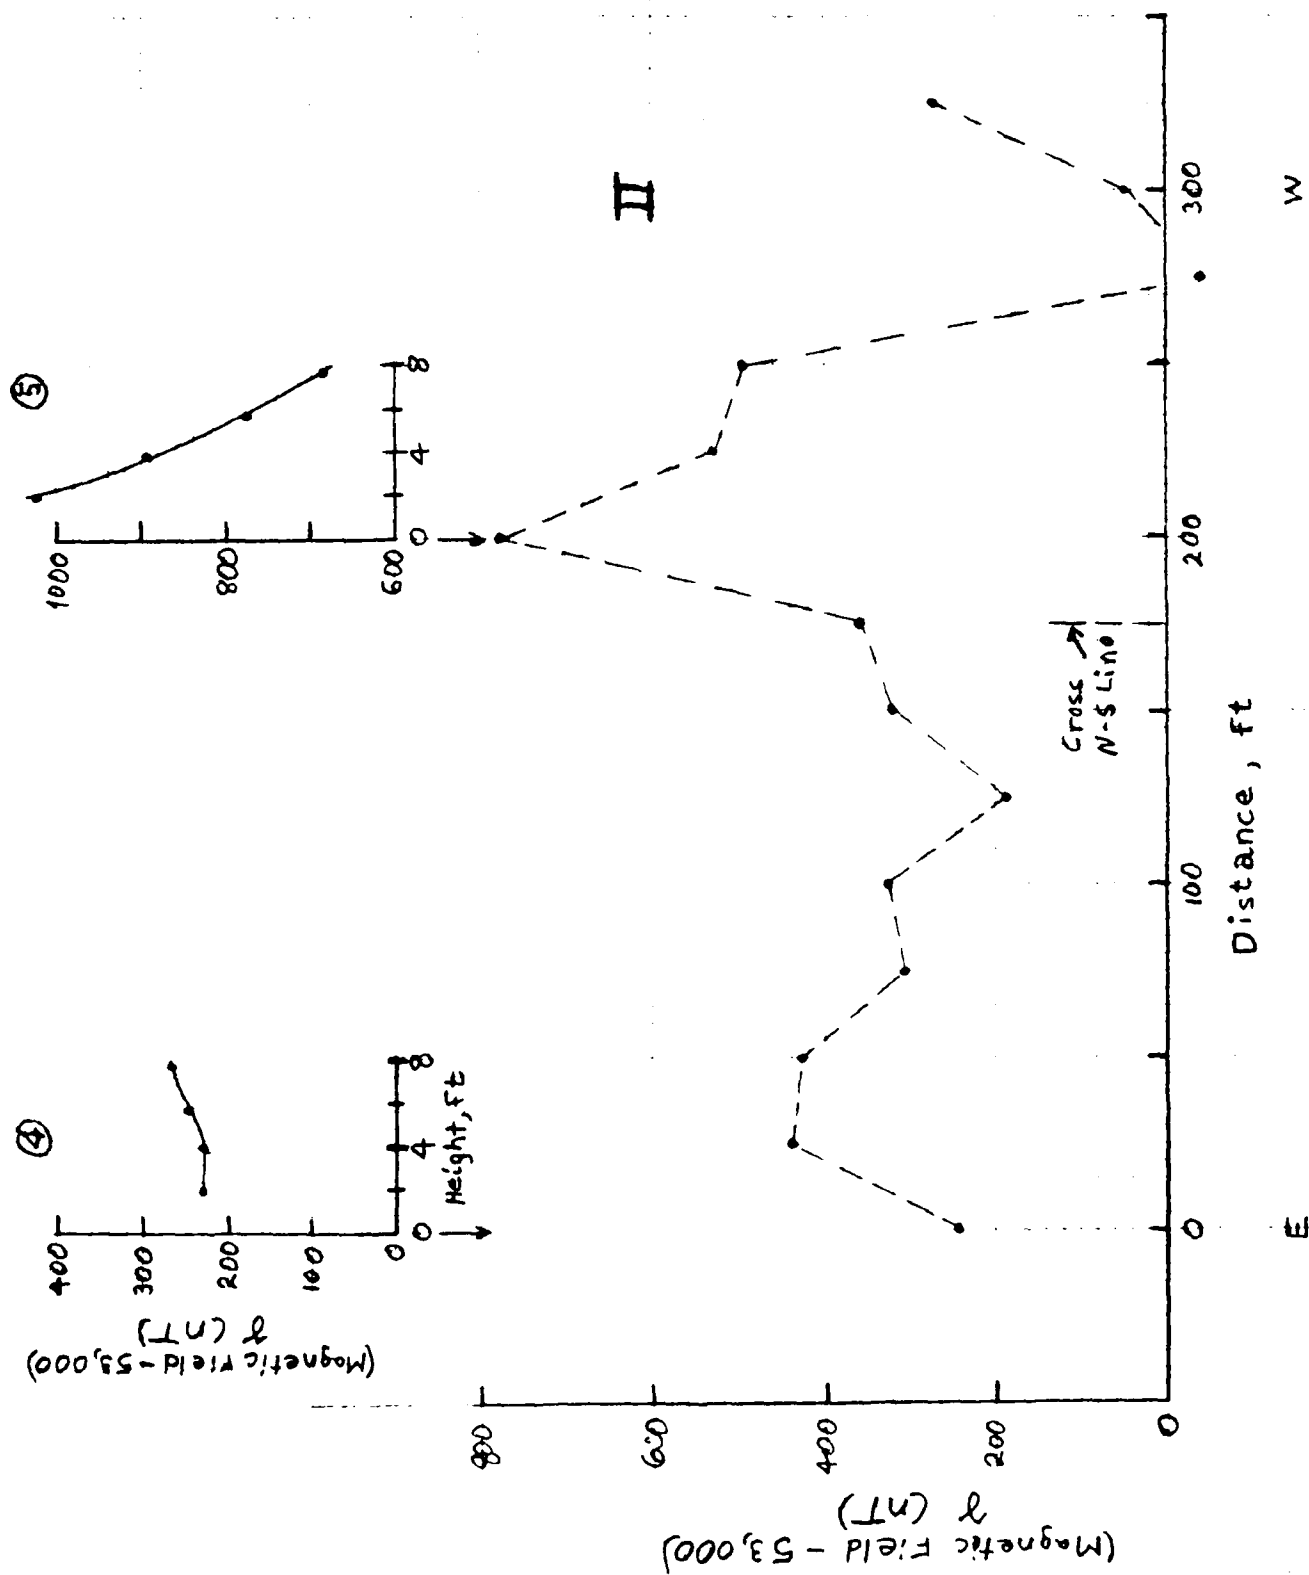
FIGURE 3. MAGNETIC SURVEY LINE II

and 5, on the hardstand, have a large positive gradient; whereas, location 3, on the hardstand approach, has a very large negative gradient. These results are consistent with the magnetic profiles in Figures 2 and 3, in that the magnetic field on the hardstand is anomalous; whereas, the magnetic field off the hardstand is subdued and nearly constant.

The magnetic survey results in Figures 2 and 3 indicate the nature of the problem at the hardstand location: considerable variation of the magnetic field strength both vertically and horizontally. Horizontally, the magnetic field over the hardstand is characterized by gradients as large as 15 nT/ft, and the field is highly erratic. Vertical gradients vary considerably with location in both magnitude and sign:

A more comprehensive magnetic survey of the area over and around the calibration hardstand is recommended in order to better characterize the magnetic field variation. In conjunction with this survey, a recording magnetometer will be deployed to monitor for magnetic field variations at one location as a function of time. During the recording time, the nearby radar system should be cycled on and off at least twice; the off time would not have to be lengthy ( < 1 hr). During the on and off times, the magnetic field would also be repetitively surveyed along at least two orthogonal survey lines in addition to the continuous recording.
